The District Municipality of Muskoka

**Contaminated Sites Screening Report  
Bracebridge North Transportation  
Corridor, Bracebridge, ON**

AECOM

October, 2013

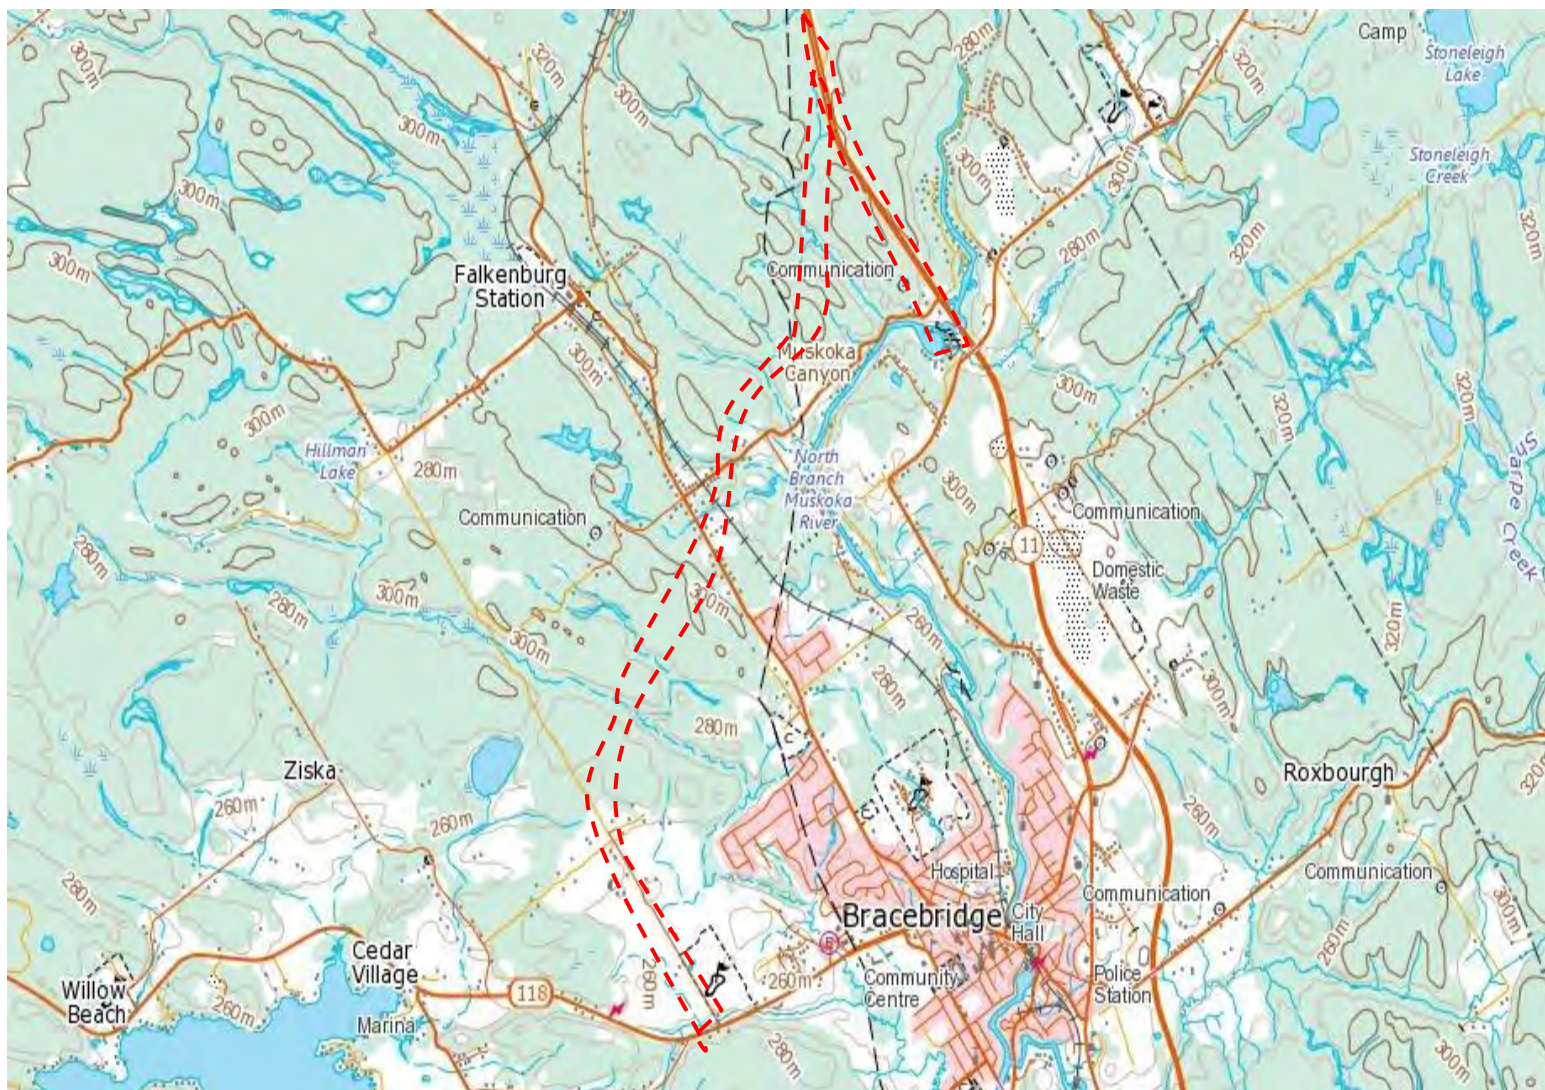
**Figure 2.**  
**Topographic Map**

Location of CSS Area  
Scale: NA  
Source: NRCAN

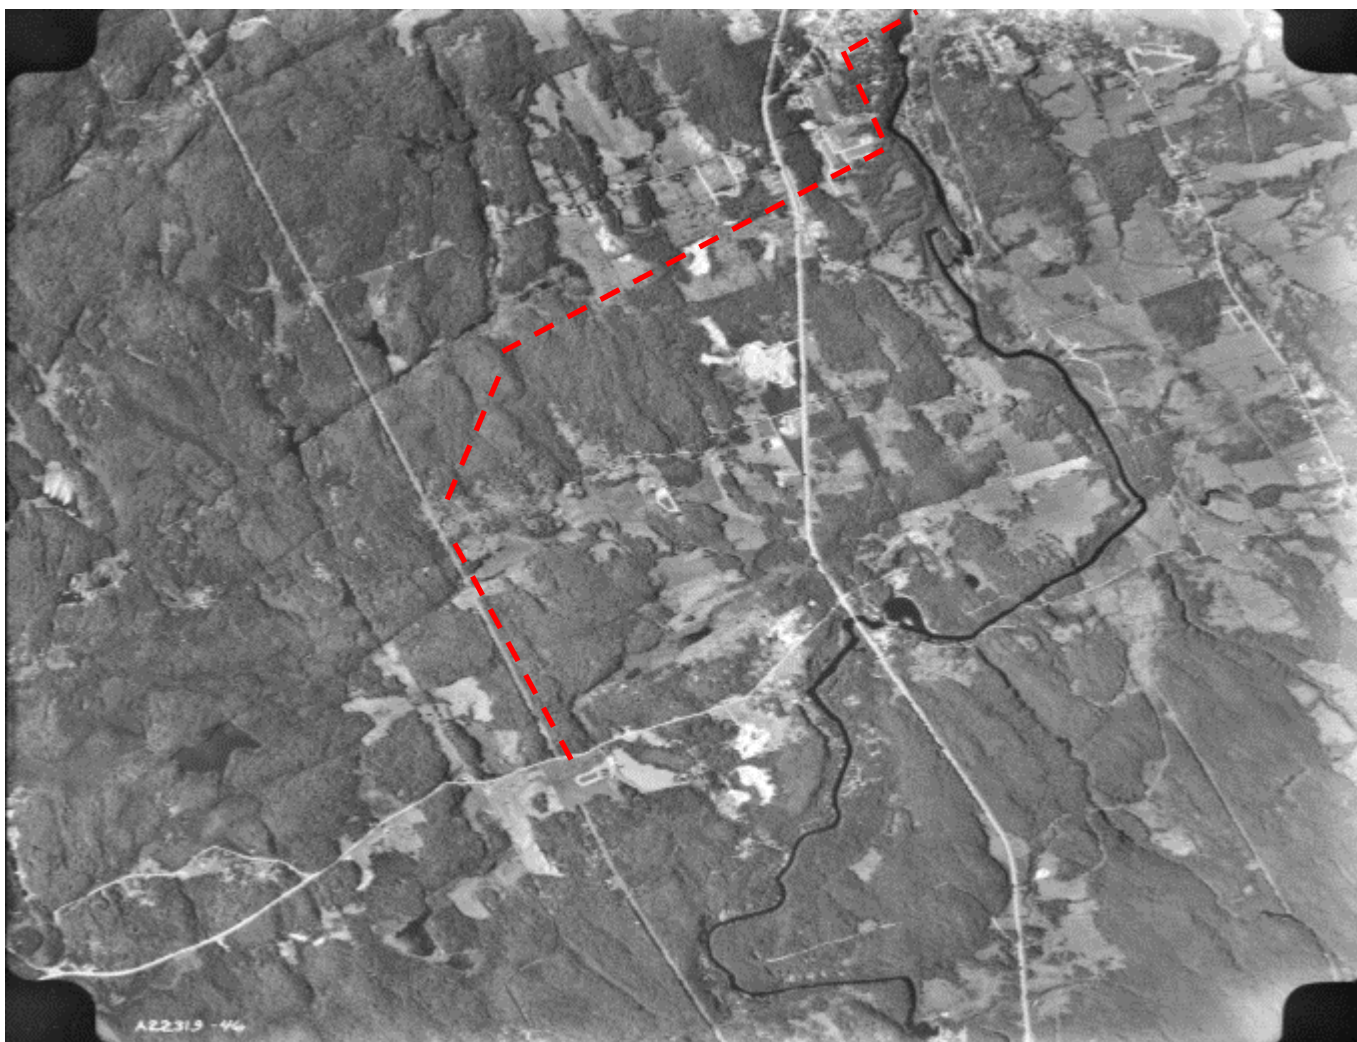
**Aerial Photograph – 1971**

The 1971 aerial photographs revealed the CSS Area and surrounding property land uses to be similar to those identified in 1967. No changes were observed in the CSS Area.
